# Lane Plating Works

**City of Dallas Community Meeting  
April 17, 2017**

**U.S. EPA Region 6**

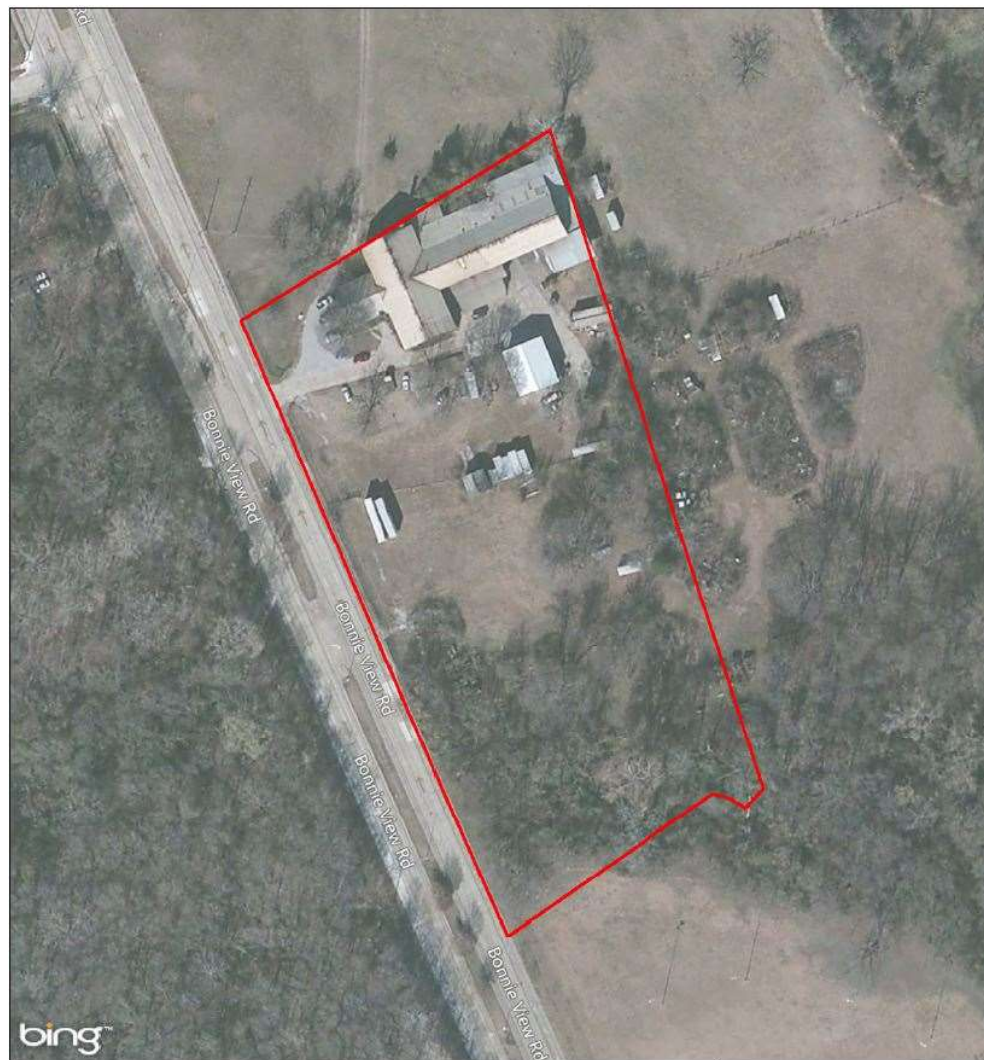
# Site Property

- ▶ Located on Bonnie View Road between E. Ledbetter Drive and Simpson Stuart Road immediately north of College Park
- ▶ Operated as an electroplating facility for approximately 90 years.

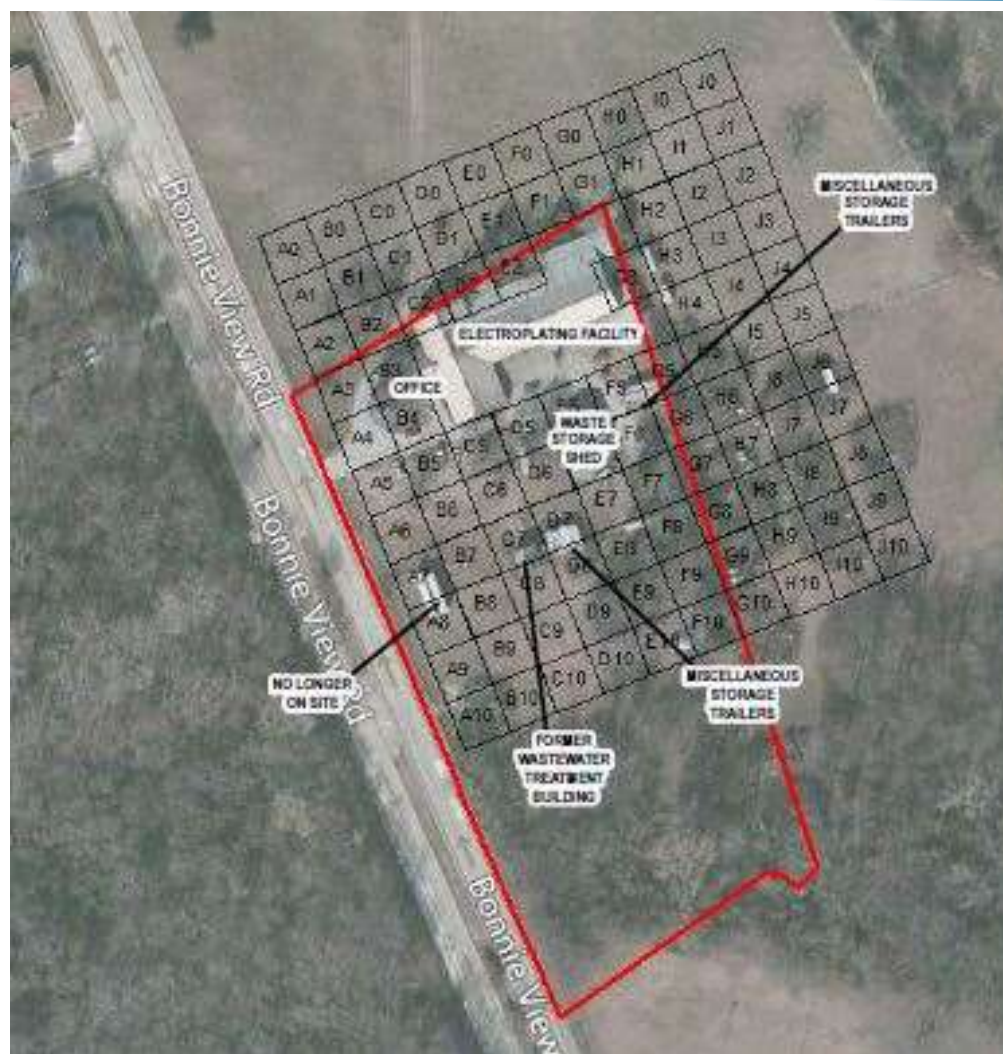
# Soil Sampling Grid

- ▶ Soil sampling conducted:
  - April 12 – 13, 2016 (initial Removal Assessment)
  - Sept. 19 – 23, 2016 (in conjunction with the Removal Action)

- ▶ Most common metals detected associated with Lane Plating operations:
  - Hexavalent chromium
  - Lead
  - Mercury

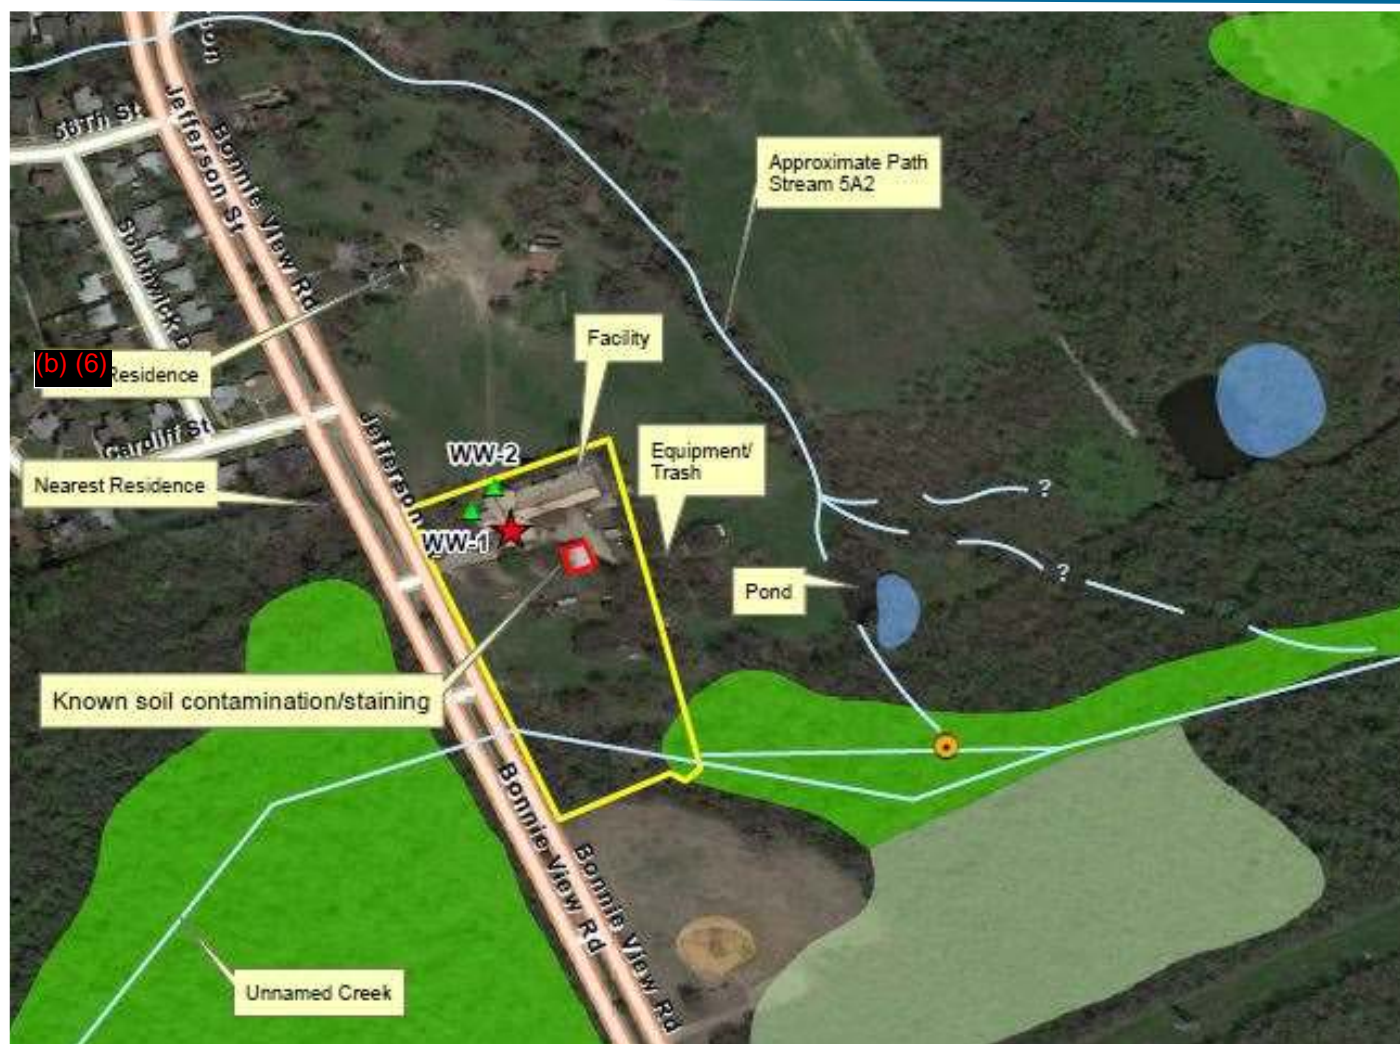
# SI Sampling Map

- ▶ Field Activities completed from July 18-21
  - Soil
  - Surface Water
  - Sediment
